Manhole Inspection Summary

Manhole # S25GG1019MH

Insp Date: **1/18/07 11:18 AM**

Location Address: **4001 HICKORY AVE**

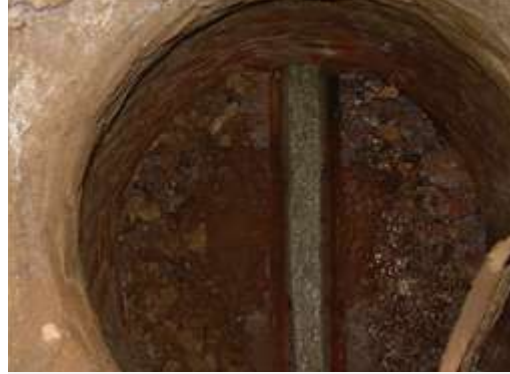
Top View

Corroded steps. Evidence of surcharge - Bench debris.

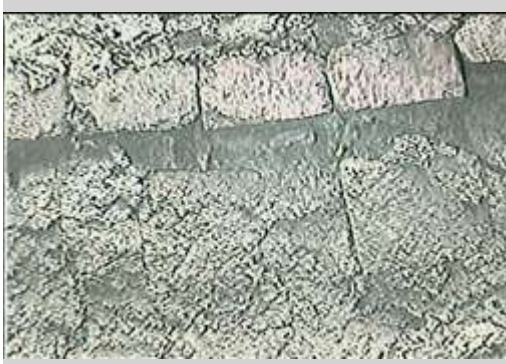
Defect

Condition: ☐ Sound ☐ Cracked ☐ Root Intrusion ☒ **Loose Brick** ☒ **Deteriorated**

Infiltration: ☐ None ☐ Joint ☐ Cracks ☒ **Mortar** ☐ Roots ☒ **Wall**

Barrel deterioration, loose brick and infiltration.

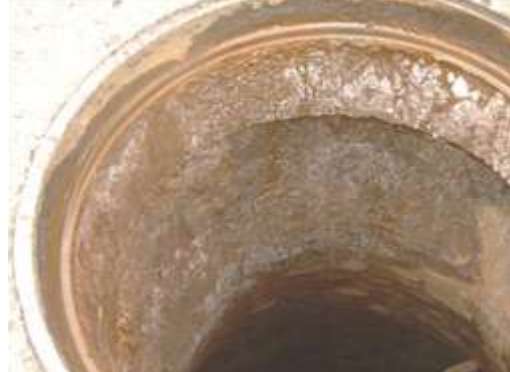
Defect

Frame Offset: **1** (in.) Condition: ☐ Sound ☐ Cracked ☒ **Leaks**

Infiltration: ☐ None ☒ **Joint** ☐ Cracks ☐ Mortar ☐ Roots ☐ Wall

Frame leaks. Adjustment infiltration.

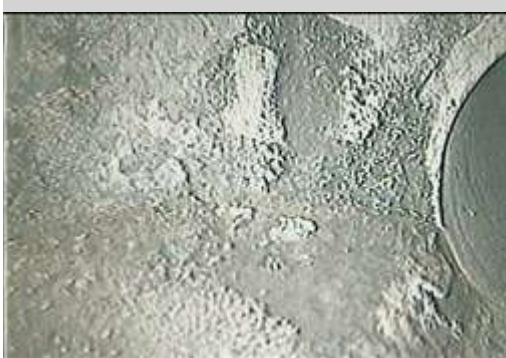
Defect

Comments **There is an Active weeper in this MH - I6 connection.**

Weeping I6 Connection - Barrel infiltration.

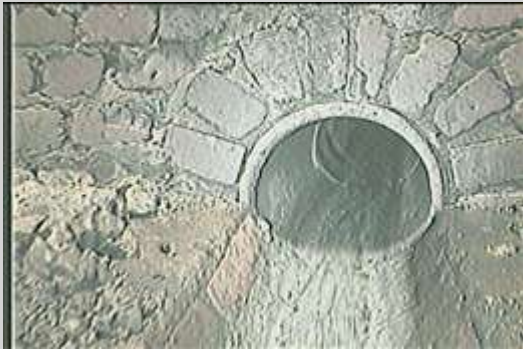
8 in. Circular Gravity Sewer Pipe Out @ 12 O'Clock

Barrel deterioration and infiltration.

Infiltration: **Evidence** Pipe Seal Cond: **Unknown**

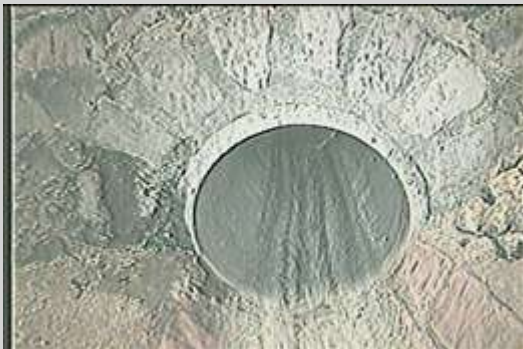
8 in. Circular Gravity Sewer Pipe In @ 6 O'Clock

Infiltration: **Weeper** Pipe Seal Cond: **Broken**
